## Radial shaft seal, transmission output Citroën / Peugeot

Das Original **504.581 / 505.090 / 128.240 / 128.250**

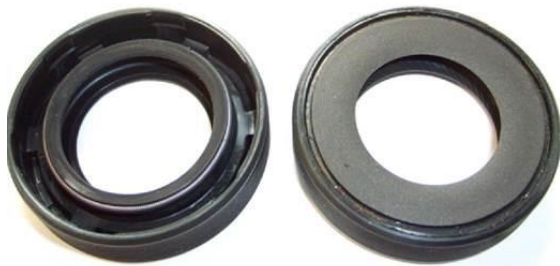
With some radial shaft seals located on the transmission output side a plastic disc/ring is inserted in front of the actual sealing lip.

This disc acts as protection when the drive shaft is installed and prevents the penetration of dirt and foreign bodies during operation. This is essential due to the fact that the region is exposed, i.e., no pulley or gears/cogwheels are positioned in front of the seal.

The image shown is for illustrative purposes only (

505.090).

The seals

504.581,

128.240, and

128.250 have a slightly different design (color/shape), but the protective disc/ring has the same function.

**These protective rings are located on the exterior and must not be removed prior to or during installation!**

The replacement of the radial shaft seal must be performed with suitable equipment.
